Lessons Learned: Dropped Object

Traction: IR-3143950

P&A Cement Annulus Top Out – Wyoming, Moxa OC Wells

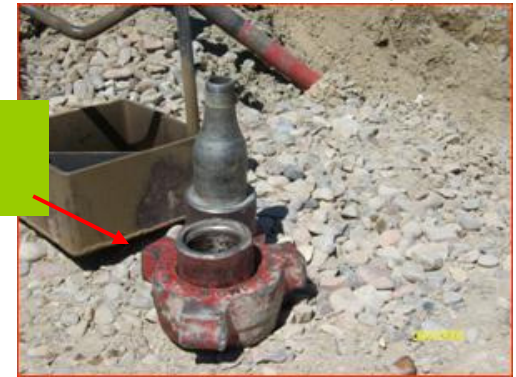
Dropped object, 14 lbs

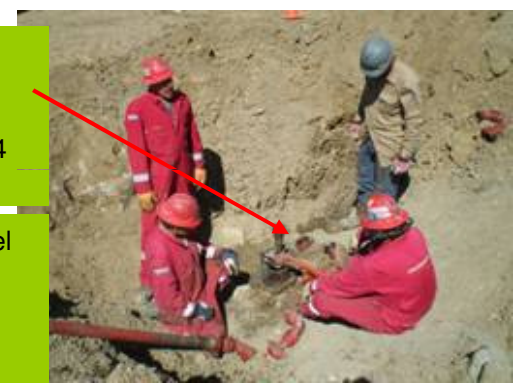
Resting place of dropped object, 14 lbs

Personnel positions when the incident occurred

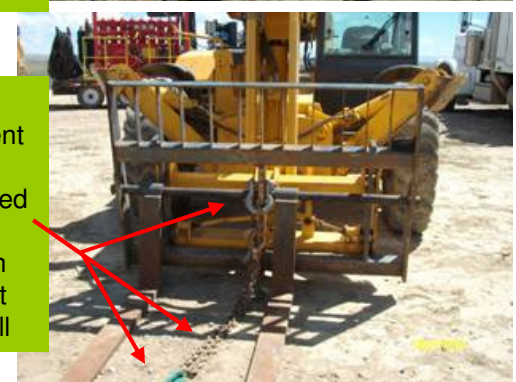
Rigging attachment on the forklift used for lifting the 1 inch piping out of the well

- Directive given that no unapproved lifting devices will be used. Team will source the correct slips, elevators and proper lift nubbins for this type of activity.
